## Modifications to CC19 Hatch Cover Arrangement

By David Peck

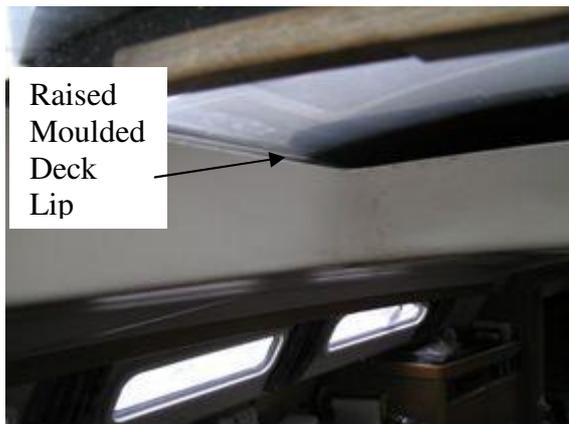
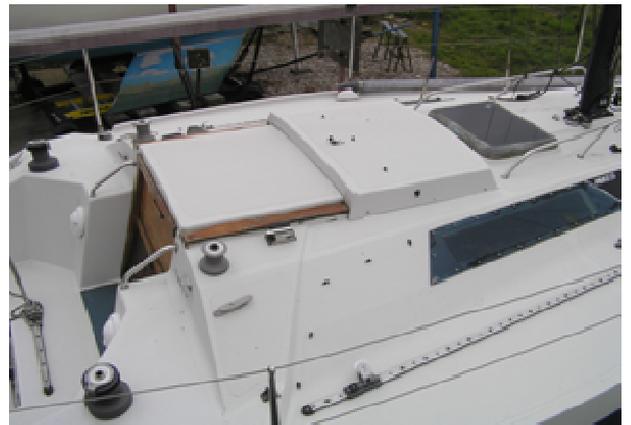
The design of the CC19 hatch arrangement is unusual but this is for a very good reason. Most sliding hatch covers overlap a raised moulded lip section on three sides of the coach roof; hence any water always runs off onto the deck. A garage installed behind the sliding hatch helps to protect it when open and prevent any water or waves getting under the forward edge (see photographs of some typical hatches below).

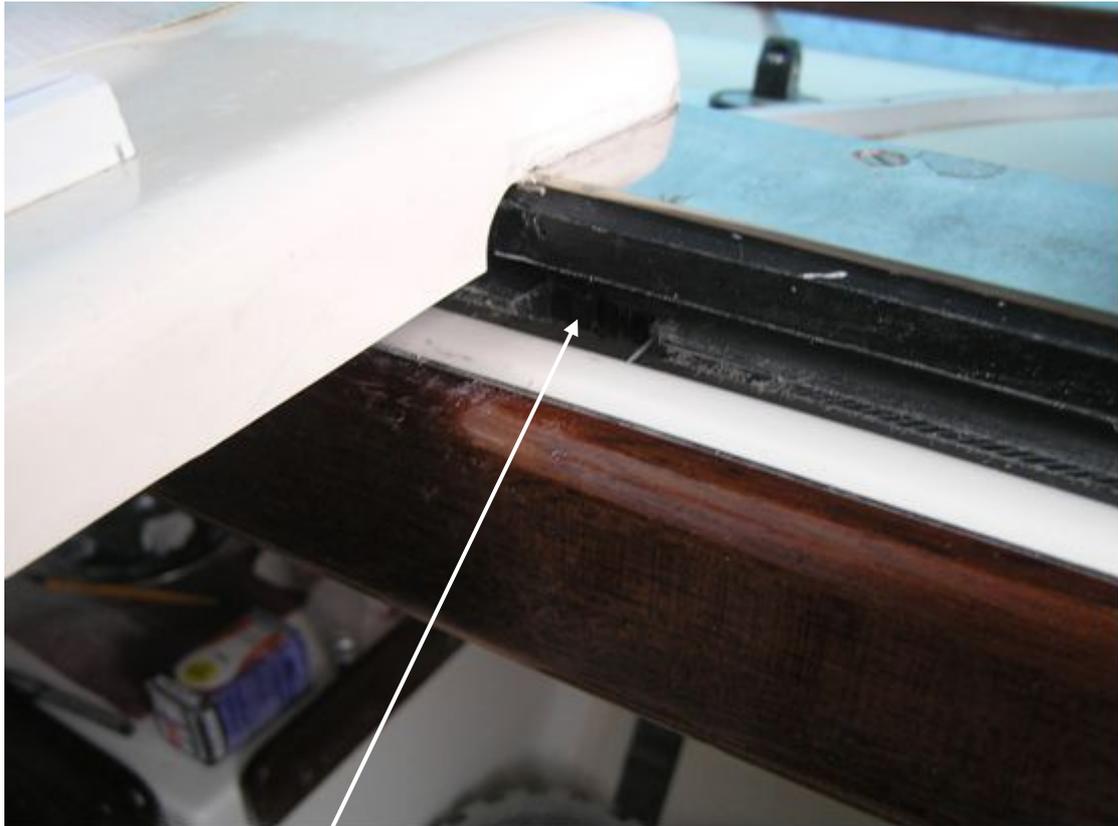
This type of design does, however, require a more precise sealing arrangement. The current design employs two plastic machined runners to enable the flat Perspex hatch to slide open and close (see photograph below). The runners are screwed to an outer raised moulding lip. Water is prevented from entering forward into the cabin by a double lip seal fitted to a metal channel mounted between the two outer raised lips just inside the front vertical edge of the garage (see photograph). This double lip seal presses onto the Perspex sliding hatch and forces the water to escape over the sides of an inner raised moulded lip and into the plastic side runners. The Perspex hatch cover has slots cut in them (one each side) just in front of the lip seals (when the hatch is fully closed – see modification drawing). Also, immediately below these cut outs, the lower edge of the runner is removed to allow water to run off the hatch, through the slot and drop down and run out between the inner and outer raised moulding lips and finally out from holes in the garage sides.

**Plastic runners – note lower edge of groove cut away just in front of garage**

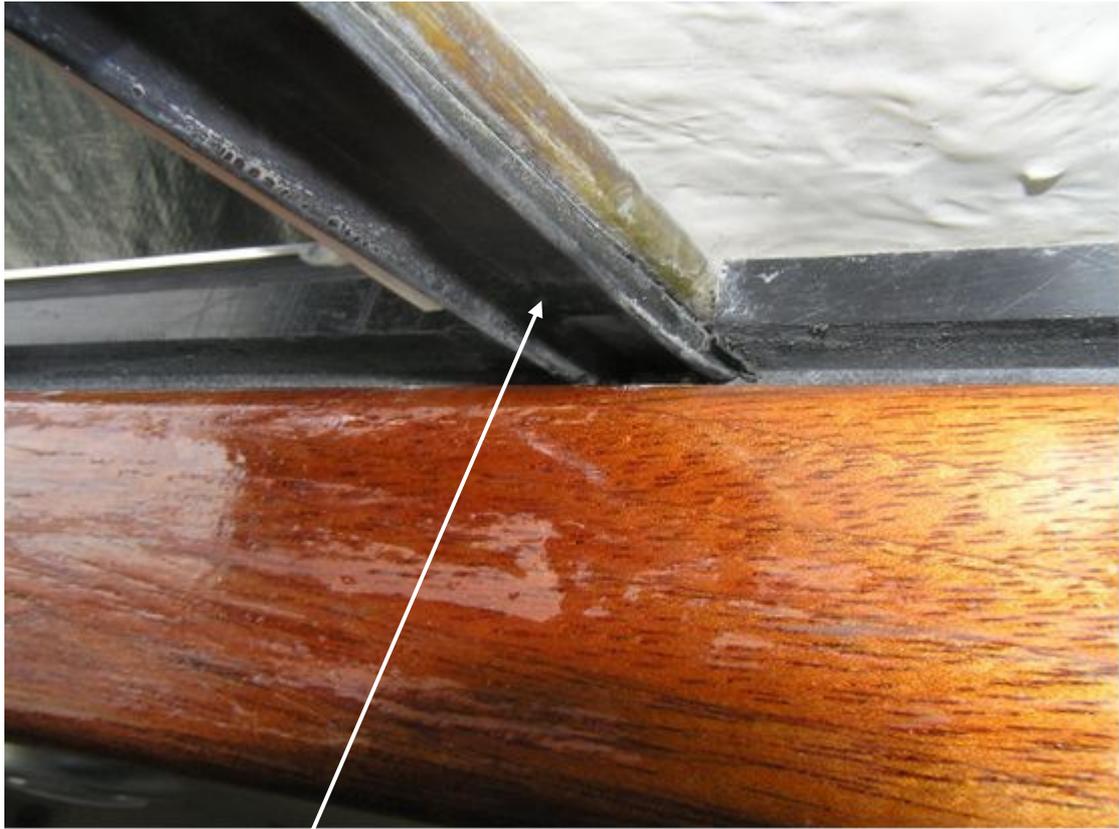
**Double rubber lip seal**

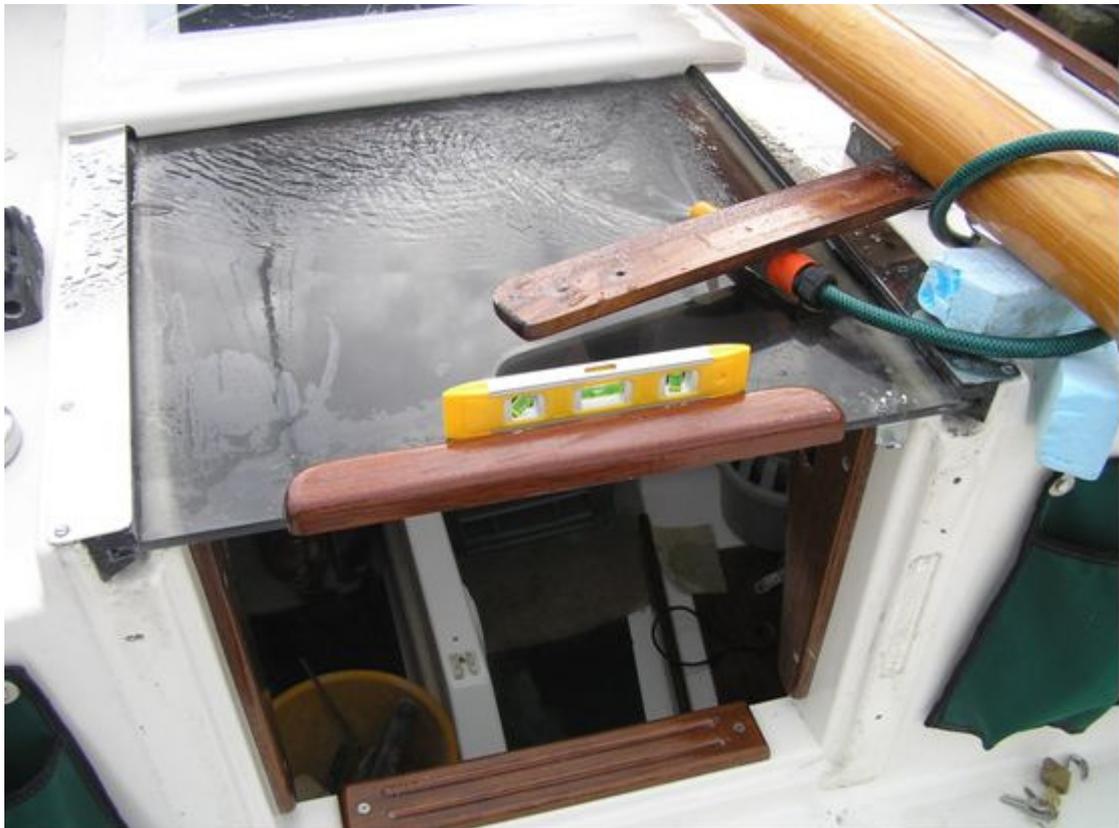
**Testing to prove source of leaks**

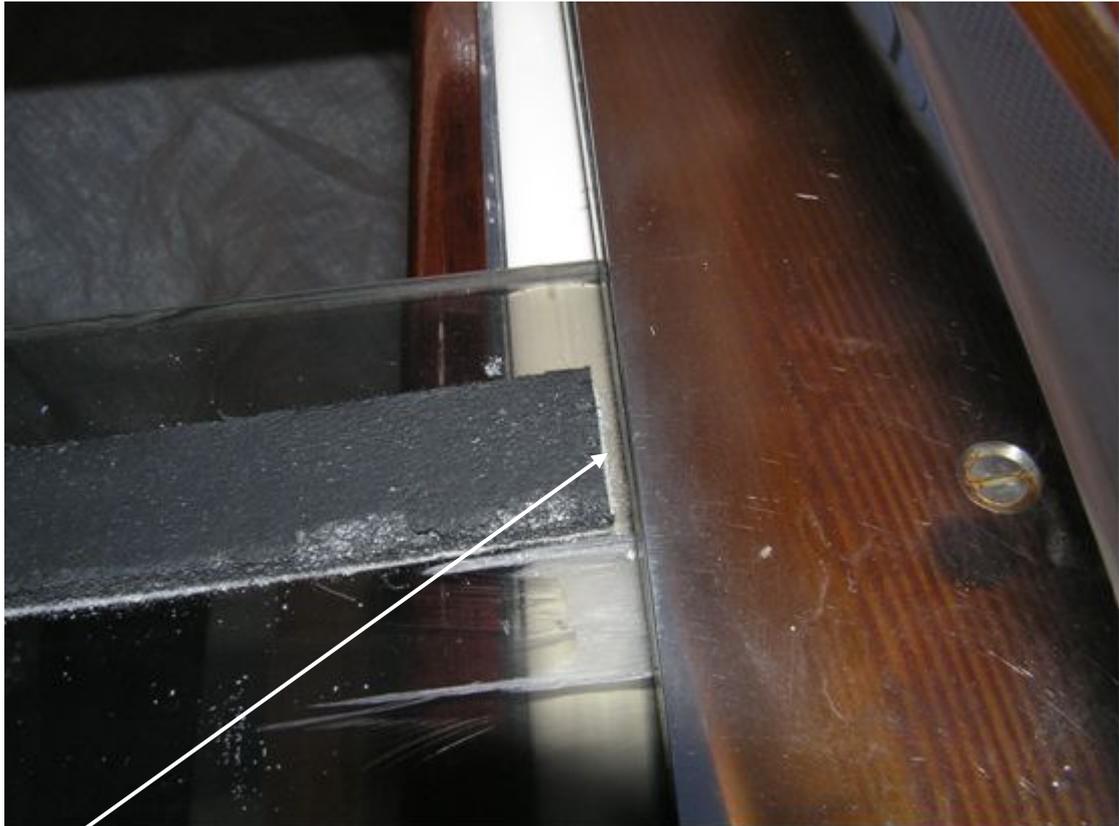
Some water can get past this sealing system and is catered for by fitting a foam rubber sealing strip near the top inner edge of the sliding Perspex cover. Again, this is intended to force the water to run into the side runners and out between the inner and outer raised moulding lips. Unfortunately, if there is a slight gap between the edge of the sealing strip and the runners, water can get round and drip off the front edge of the Perspex cover and drip into the cabin (see photograph showing gap). It is probably this fact that has caused some boats to suffer leaks from their sliding hatches.

**Gap at end of sealing strip**

Fortunately, there is a simple solution to prevent the leaks from happening. This involves milling or filing two chamfered slots immediately in front of the foam rubber sealing strip (see the photographs and instructions below). I carried this out on "Whistling Rufus" CC94 and successfully tested it for 4 hours (see photograph). The modification itself only took one hour.

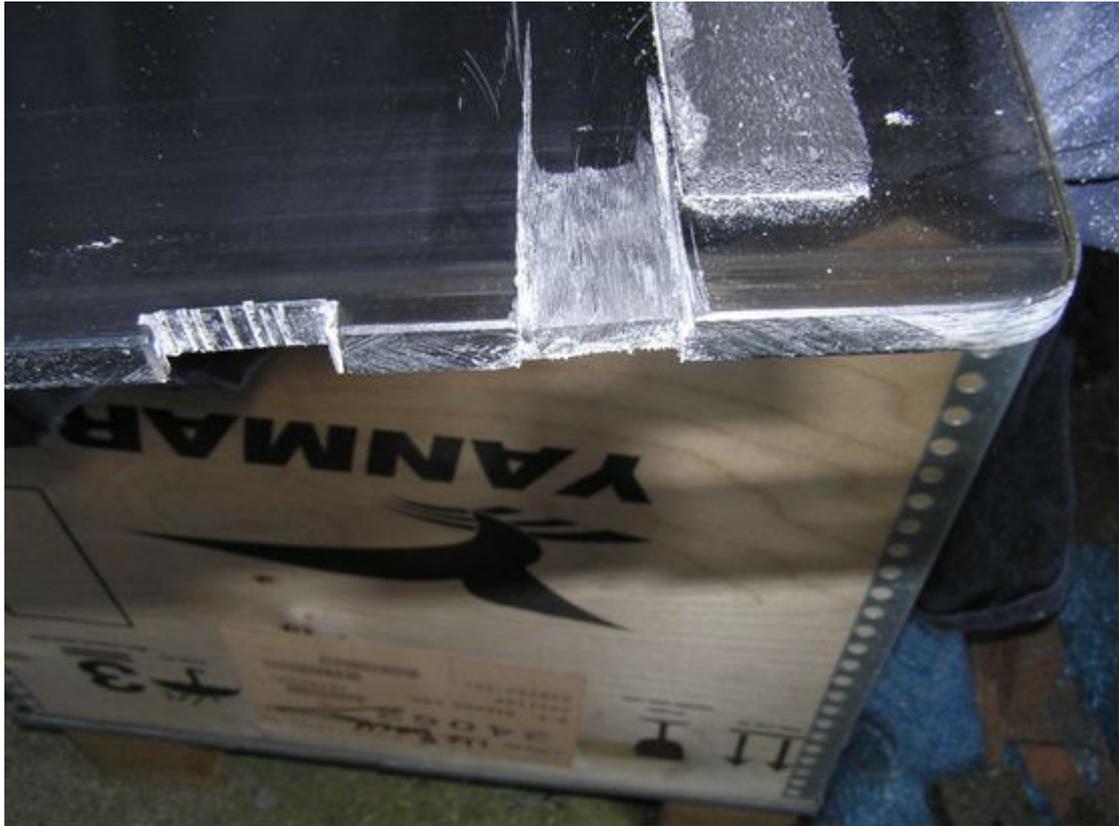
**Filing chamfered slot in front of sealing strip**

3. Mill in (or file) the two chamfered slots immediately in front of the foam rubber strip as shown in the drawing above. It is important that the start of the slot goes well past the end of the sealing strip.

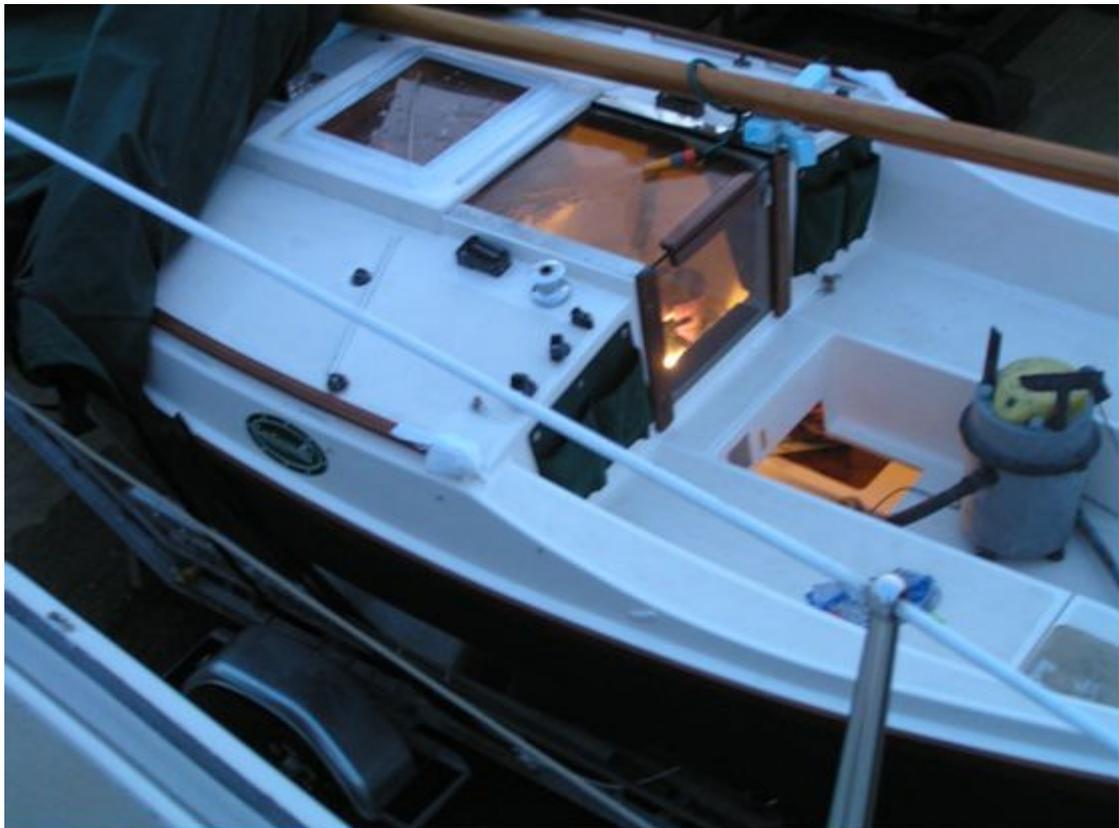
**Testing into the night**

1. With the boat slightly down on the bows and the hatch fully closed, place hose on top of the Perspex sliding cover and direct water flow under forward hatch lip seal.
2. After 1 hour (minimum), check for leaks.

Note: This modification was carried out and tested for 4 hours on CC19 No.94 "Whisting Rufus" on 21.03.2010. There were no leaks found and water was observed running out of garage side exit holes as normal. This modification means it is not necessary to have an exact butting of the sealing strip against the edge of the tracking groove. Also it is now possible to allow a little more side float of the sliding hatch to allow it to open and close more freely.

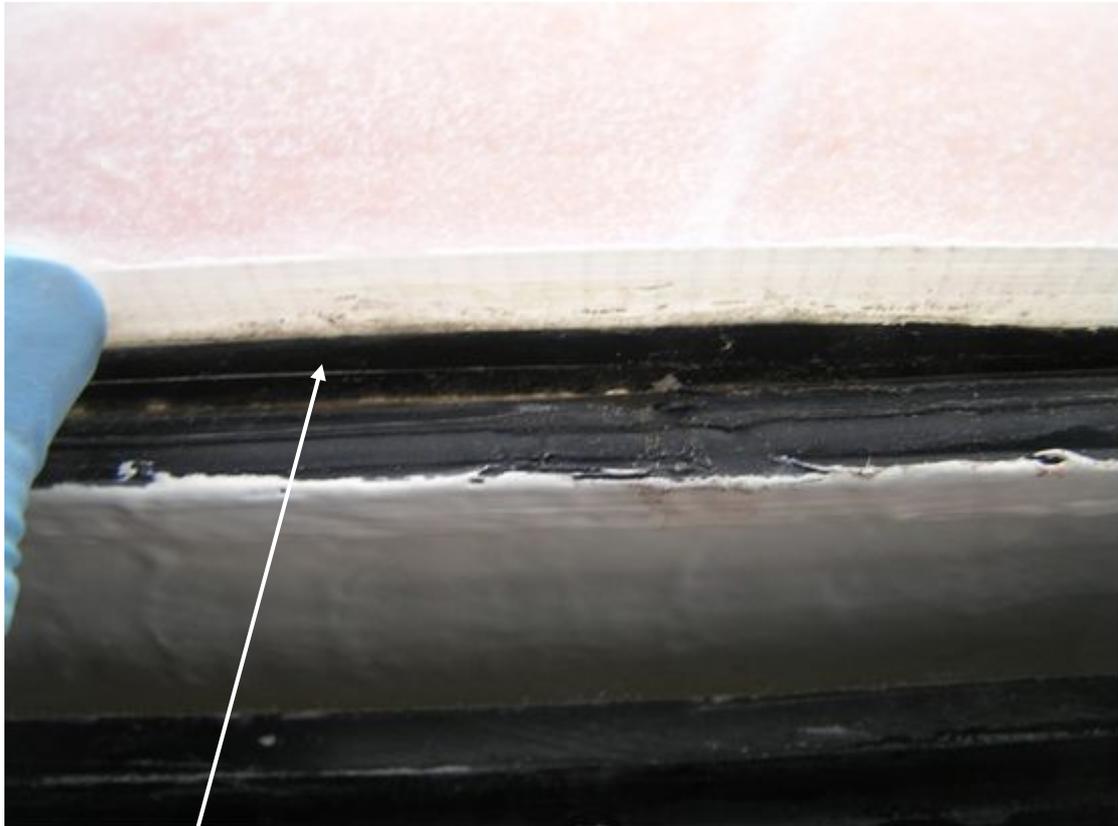
The front end of the g.r.p. garage has a Perspex window retained in a moulded recess using a sealant. The seal between the Perspex and g.r.p. can eventually fail and cause leaks (see photograph below).

### Gap between sealant and Perspex window

Due to flexing, it is important to achieve a strong adhesive bond between the Perspex and the g.r.p. gel-coat surface. In a recent Post I recommended using "Sikaflex" 295 UV to obtain a good bonding. I have since spoken to Sikalfex technical people who have confirmed my choice of sealant grade but also recommended that the Perspex is first primed with Primer 209 and the g.r.p. moulding is primed with Primer 206 GP.

It is important get the Perspex seated down on a good bedding of sealant before "skinning" of the sealant surface commences.
